TYPICAL PERFORMANCE REDUCTIONS IN PV MODULES SUBJECT TO SOILING IN A TROPICAL CLIMATE

H. O. Njoku^{1, 6,*}, K. M. Ifediora², P. A. Ozor^{4, 5} and J. M. Dzah⁶

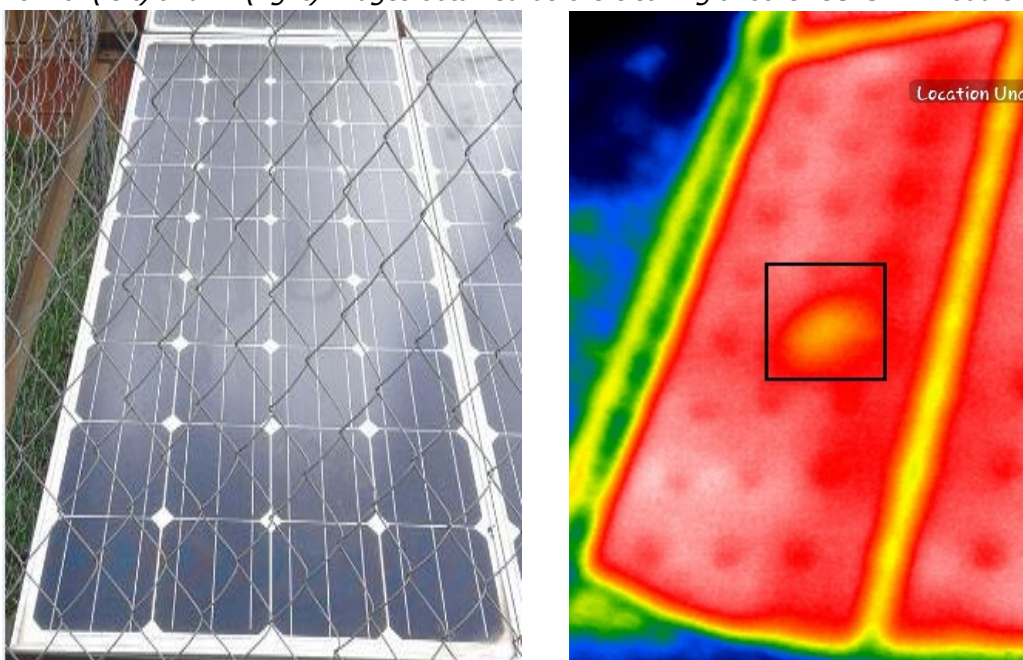
On the left of Fig. 5 is shown the normal image of the module of Fig. 3 after the system had been

cleaned to remove the droppings and dust deposits. Its corresponding IR thermogram is shown on the right of the figure. Inasmuch as the dirt and droppings were well removed, the IR thermogram shows that a permanent defect on the PV module may have resulted from the impact of the stone, which remained even after the cleaning.

Fig. 5: Normal (left) and IR (right) images of PV module surface obtained after the installation at the USPS.

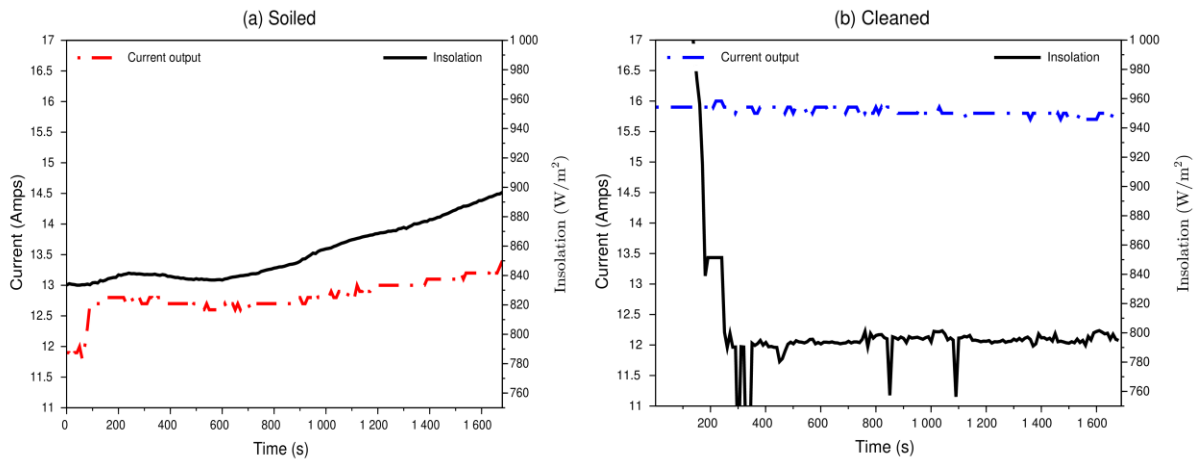
Figure 6(a) and (b) show the responses of the current outputs to changes in the insolation prevailing during the measurements on the soiled and clean modules, respectively. During the test on the soiled array (Fig. 6(a)), a gradual rise in insolation was recorded, and this caused a corresponding increase in the array's current output. The maximum short-circuit current generated by the soiled array within the test interval was 13.4 A when the radiation intensity was 896.6 W/m².

There were major fluctuations in the insolation during the tests on the array after cleaning (Fig. 6(b)), with a maximum insolation of 1,090 W/m² recorded close to the start of the test. It steadied however in the course of the test to a value of 800

W/m². The current output from the clean array was also relatively steady at a value close to 16 A. Comparing the outputs before and after cleaning, a remarkable rise in the generated current (~9 %) is observed despite the noticeable drop in insolation (~10 %). The current outputs from the PV array at the USPS are shown in Fig. 7(a) and (b), for array conditions before and after cleaning, respectively. A maximum *ISC* of 6.72 A was generated during the tests. The insolation was steadier during the test on the cleaned system, being mostly with the range of 960 to 1,100 W/m².

Fig. 6: Transient response of the current output of the NCERD solar PV array to changes in solar irradiation when (a) soiled and (b) cleaned
